Case Study: Water Treatment Style 206

CASE STUDY : In a brine concentrator, an original competitor's expansion joint failed upon start up.

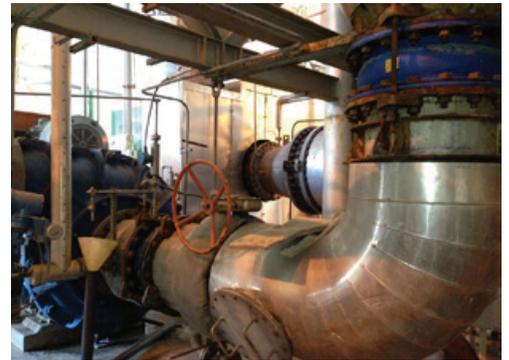
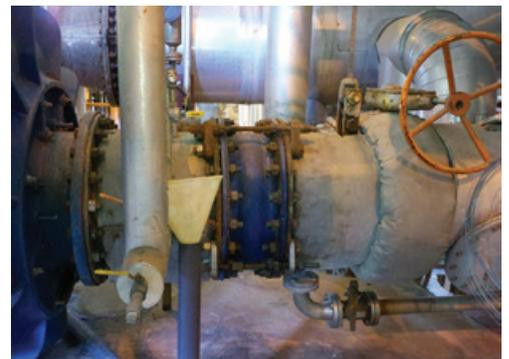
The original expansion joint unfortunately failed catastrophically without warning on start up. After consultation with the OEM of the Brine Concentrator the recommendation was that only Garlock Expansion Joints be used for this aggressive application. The original expansion joints were replaced with Style 206 expansion joints which are built with a 4 to 1 safety factor.
