**REPORT OF FIRE TEST**  
**ON**  
**TWO (2) EXPANSION JOINTS**  
**STYLE 206 (CS14A117) AND**  
**STYLE 8100 (CS14A118)**  
**FOR**  
**GARLOCK SEALING TECHNOLOGIES**  
**PALMYRA, NY**

REV. A, October 27, 2014

WRITTEN BY	<i>Salim Khabieh</i>	REPORT	14-6031
CHECKED BY	<i>[Signature]</i>	AERO NAV S.O.	6031
APPROVED BY	<i>A. J. Wignone</i>	CUSTOMER P.O.	259684
DATE	October 1, 2014	CONTRACT NO.:	
GOVERNMENT QAR	NO INSPECTION REQUIRED	NONE

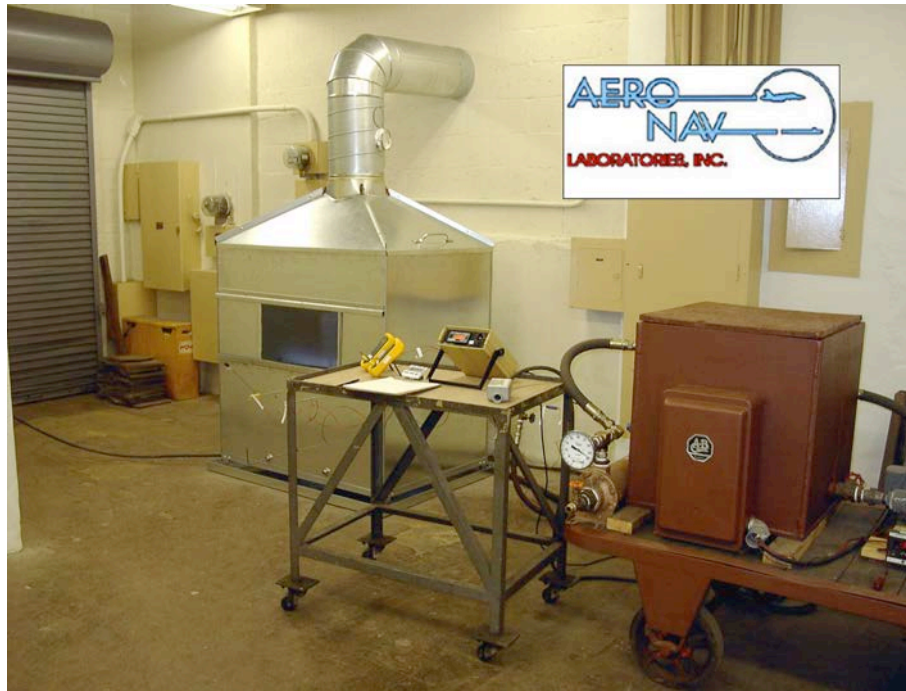
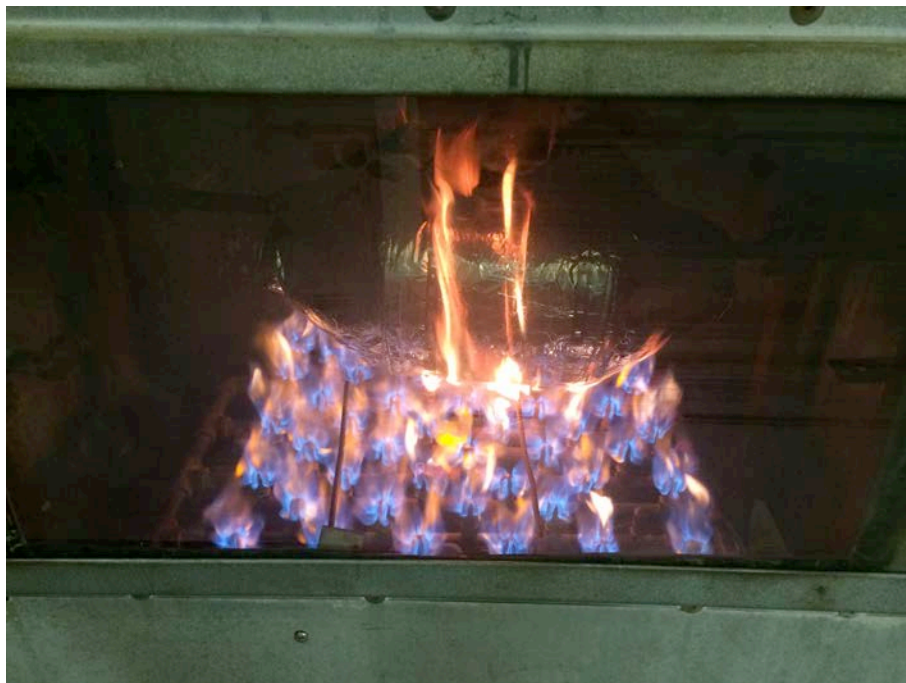
**TWO (2) EXPANSION JOINTS  
STYLE 206 (CS14A117) AND  
STYLE 8100 (CS14A118)  
GARLOCK SEALING TECHNOLOGIES  
PALMYRA, NY  
TYPICAL FIRE TEST SETUP**

Each unit in turn shall be placed within the support frame. The Hose shall be connected to the flow circuit. Water at  $(5\pm 0.2)$  Bar, flowing at approximately 3 GPM and at temperature of  $80^{\circ}\pm 2^{\circ}\text{C}$  shall be pumped through the unit. The burner shall be ignited and allowed to warm up until the test settings were verified to be stable ( $800^{\circ}\pm 50^{\circ}\text{C}$ ). The unit shall be transferred into the flame in such a manner that the burner end extends beyond a hose fitting by at least 20 mm such as that the fitting is completely enclosed by the flames. The test specimens shall be centered above the burner surface. The elapsed time meter shall then be started. All operating parameters shall be monitored continuously and recorded at 15-minute intervals throughout the test. Upon completion of the 30-minute fire test, the flame shall be removed and the flow circuit shall be stopped. The unit shall be allowed to cool slightly, and the proof pressure circuit shall be connected. When all the air is bled out of the system, a proof pressure post test consisting of pressurizing the unit to 375 psig for a 10 minute period shall be performed. The unit shall be then removed from the test frame.
