# Case Study: Mining Style 204EPS

## Extreme Pressure Service

**CASE STUDY :** Replacement of non-metallic expansion joints with Garlock Expansion Joints in extreme pressure applications.

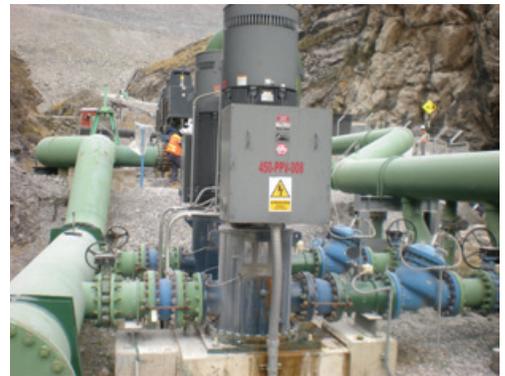
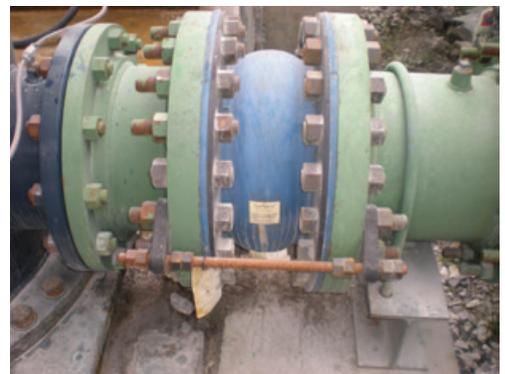
1. Size: 14 "x 8.5" FF Expansion joints
2. Temperature: 40° C
3. Application:
  - Suction with lateral deviation of 1 $\frac{3}{8}$ "
  - Goulds Pump Vertical Pump / 14 RHMO 7 Stages / 350 HP, the 150 LPS
4. Media: Water tailings.
5. Pressure (Max): 200 psi.

Non-metallic expansion joints were being replaced every year. Garlock Expansion Joints have been in service for 4 years and are still performing well.
